Little Sewickley Creek Watershed Association Water Quality Report

Sewickley Heights Borough | March 2022

Water Quality Study 2020-2021

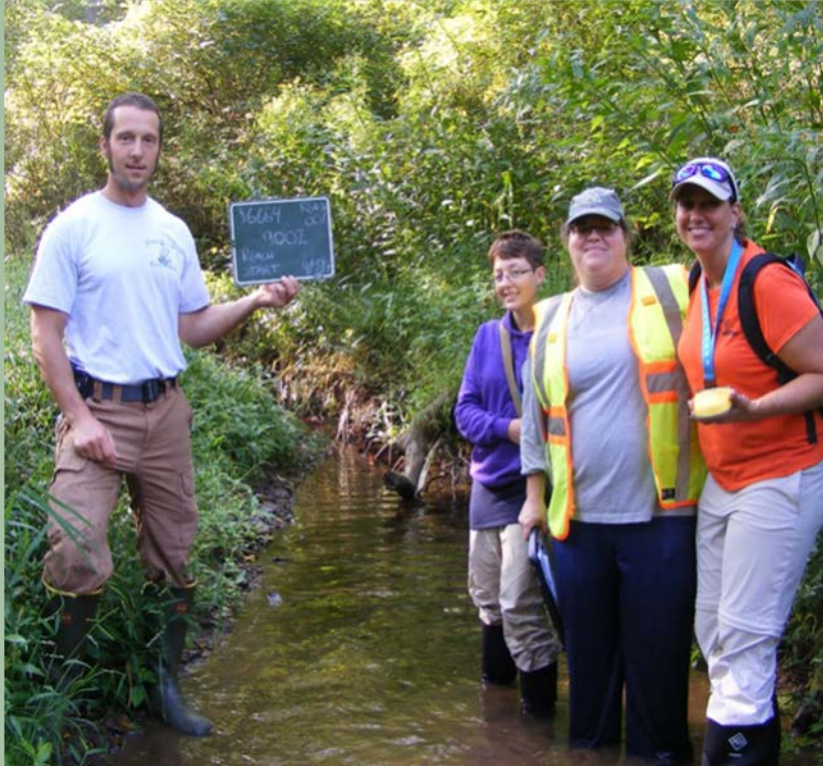
In 2017 LSCWA engaged CEC (Civil and Environmental Consultants, Inc.) to coordinate a field watershed assessment of the physical, chemical, and biological conditions in the streams of the Little Sewickley Creek watershed.

Based on the results of the watershed assessment and on data collected from a previous survey in 1981-82, LSCWA engaged CEC to do a water quality study of selected streams in the watershed.

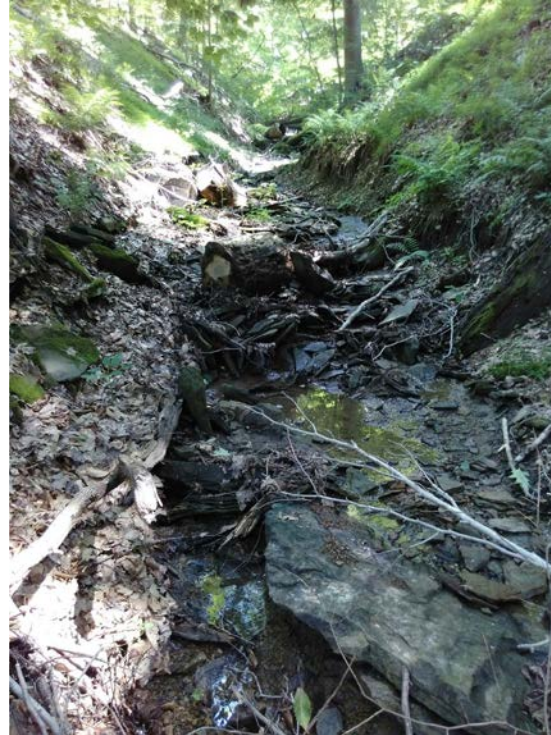
Downstream of 36662-1

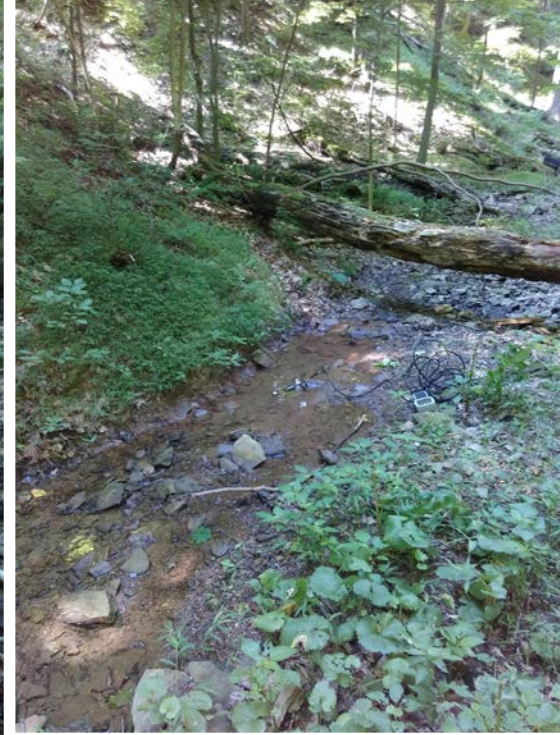
Downstream of 36662A

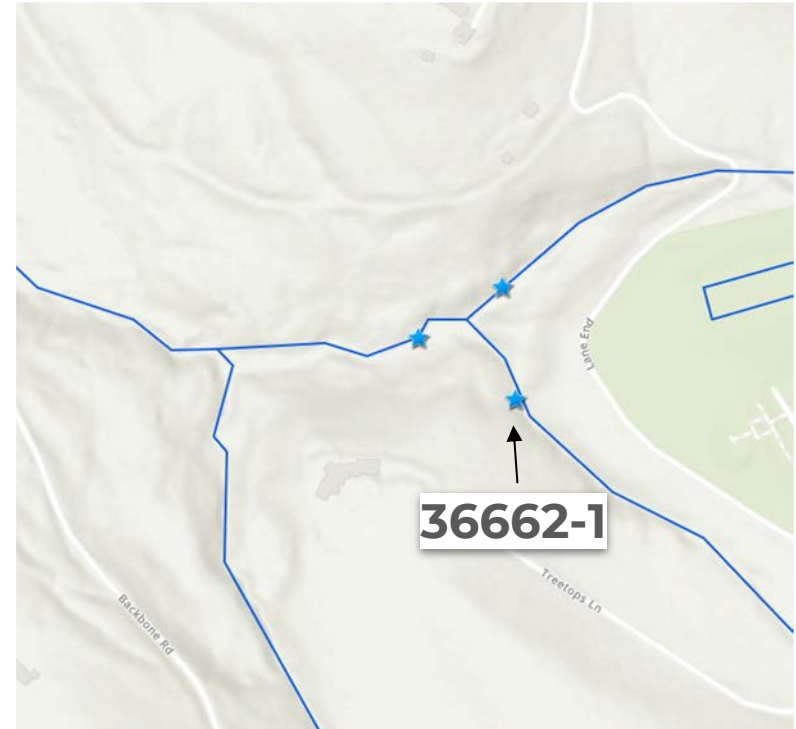
Backbone Road Site 36662-1 | Aluminum & Chloride

Water samples at [36662-1](#) exceeded the [Chap. 93 PA State Water Quality Standards](#) for aluminum (0.75 mg/L) in September 2020 and chloride (250 mg/L) in September 2020 and June 2021.

Date	Aluminum	Aluminum Excess %	Chloride	Chloride Excess %
Sept. 2020	0.85	+13%	268	+7%
Dec. 2020	0.067	-	199	-
Mar. 2021	0.077	-	164	-
Jun. 2021	0.28	-	260	+4%

Road salt mixing with precipitation and entering streams would be the most likely source of elevated chloride and total dissolved solids at Backbone Road site [36662-1](#).

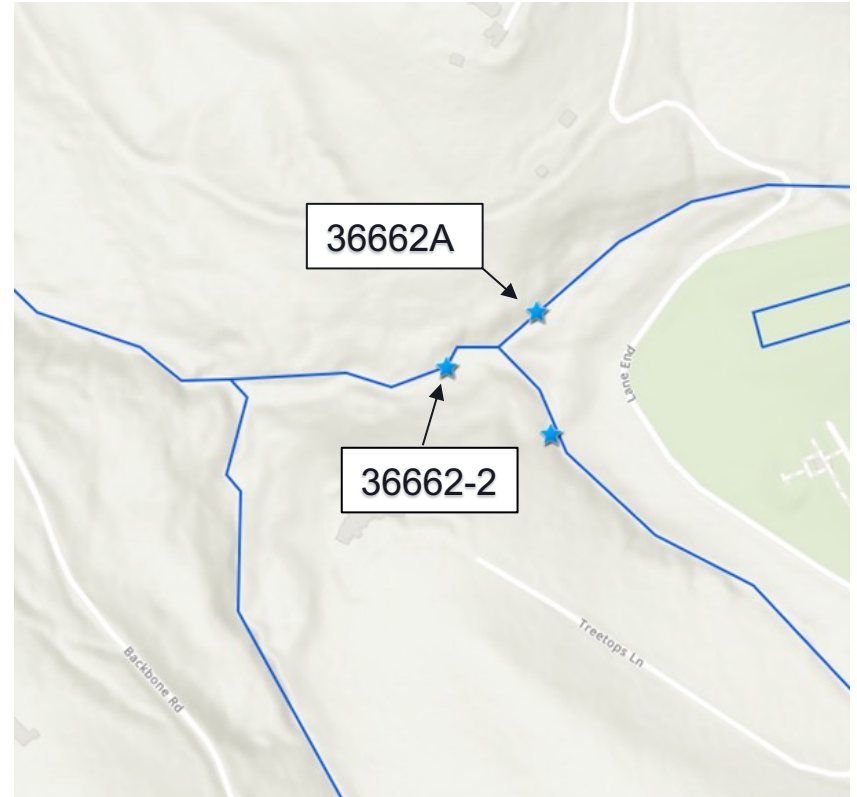
Backbone Road Site | Phosphates

In September 2020, December 2020, and June 2021 samples collected at [36662-2](#) and [36662A](#) contained elevated levels of phosphate averaging 0.90 mg/L compared with the average of 0.36 mg/L for all twenty observed sites during the same time period.

Elevated levels of phosphates (common in turf fertilizer) observed at [Backbone Road](#) sites could be related to **surface water runoff from areas around maintenance/storage buildings at Allegheny Country Club.**

Ensure Allegheny Country Club is implementing best management practices for storing and handling turf fertilizers which are the probable sources of excessive nitrate and phosphate pollution into the [Backbone Road](#) sites.

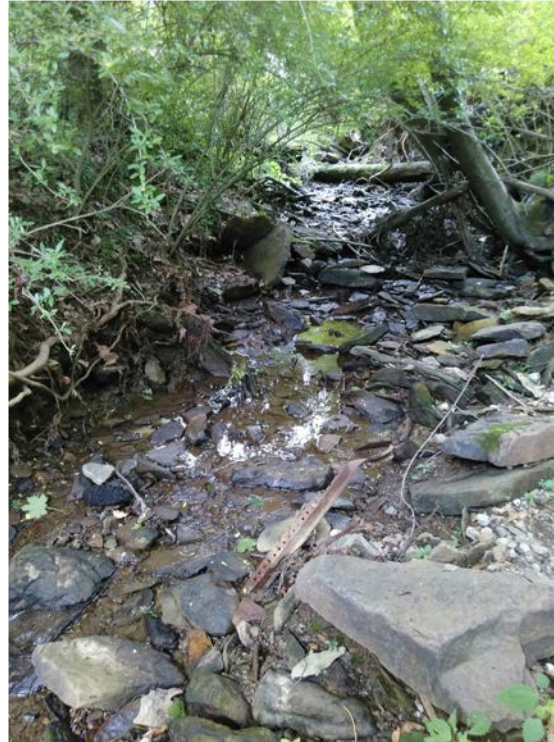
Upstream of FH-2

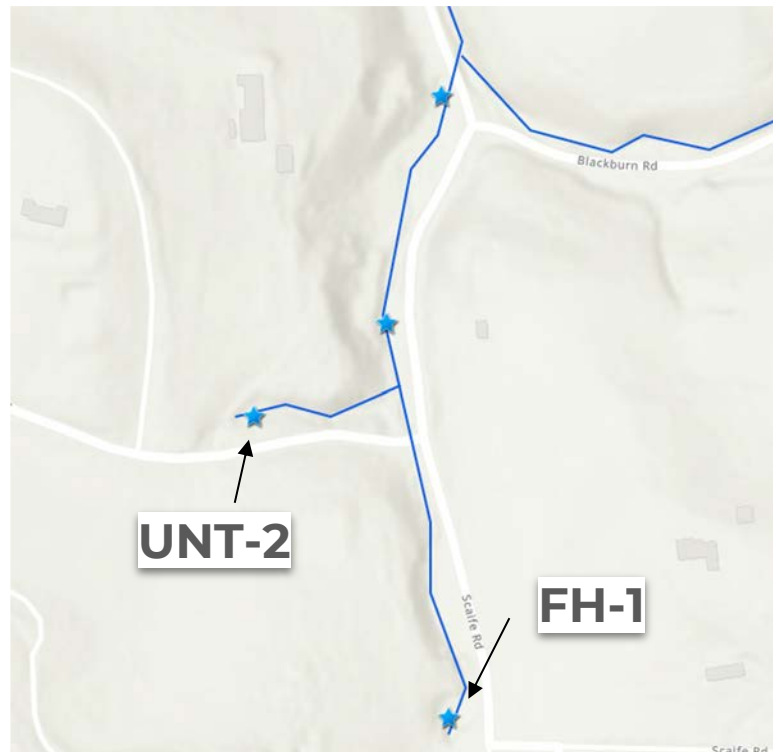
Fern Hollow Headwater | Fecal Coliform Bacteria

Water samples at [UNT-2](#) and [FH-1](#) exceeded the [Chap. 93 PA State Water Quality Standards](#) for fecal coliform bacteria (200 colony forming units/100 ml).

Date	UNT-2	UNT-2 Fecal Coliform Excess %	FH-1	FH-1 Fecal Coliform Excess %
Sept. 2020	104		345	73%
Dec. 2020	TNTC*	+400%	857	329%
Mar. 2021	231	16%	109	
Jun. 2021	112		264	32%

Elevated fecal coliform bacteria at the [FH-1](#) and [UNT-2](#) sites suggests a **leaking sewer line** or **poorly draining septic fields**.

Develop plans to remove the sources of sewage and grey water and/or control the infiltration.

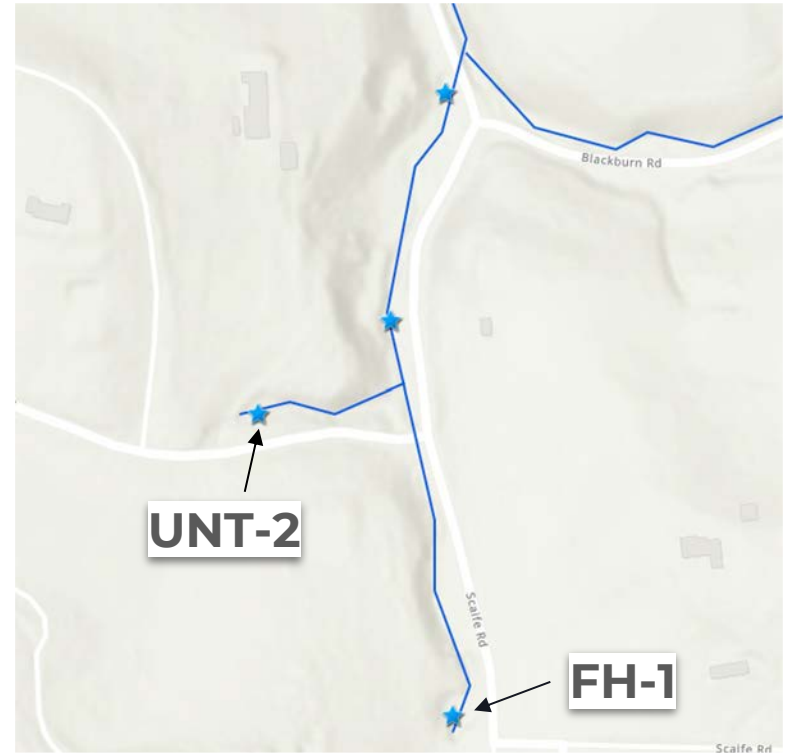
Fern Hollow Headwater Sites | Additional Contaminants

- Elevated levels of **anionic surfactants** used in detergents and common in gray water were detected at
 - [UNT-2](#) in December 2020 and March 2021
 - [FH-1](#) in March 2021
- Elevated levels of **chemical oxygen demand** indicating greater levels of oxidizable organic matter and lower amounts of dissolved oxygen available to aquatic life forms were detected at
 - [UNT-2](#) in September 2020 and March 2021
 - [FH-1](#) in in September 2020

Elevated levels of anionic surfactants used in detergents and chemical oxygen demand at [FH-1](#) and [UNT-2](#) suggest **leakage of gray water** from neighboring properties.
