BASELINE STUDY OF THE HYDROLOGY AND MORPHOLOGY  
OF LITTLE SEWICKLEY CREEK, SEWICKLEY, PA

Prepared under the direction of Dr. Marie Morisawa  
for the Little Sewickley Creek Watershed Association

This report presents the results of a study on the hydrology and morphology of Little Sewickley Creek, authorized by the LSCWA.

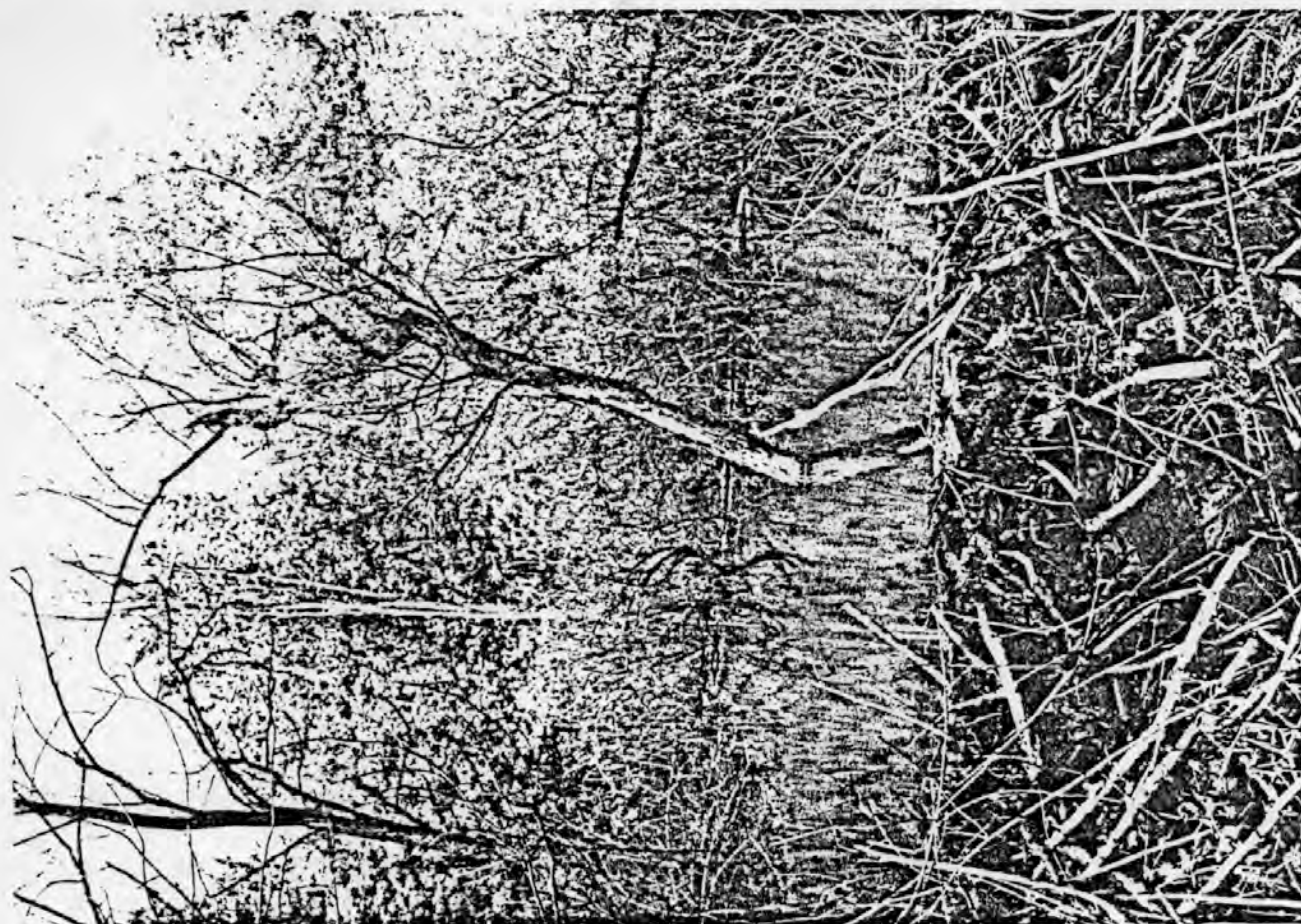
Plate 1. Beaver dam at Fern Hollow Trib.

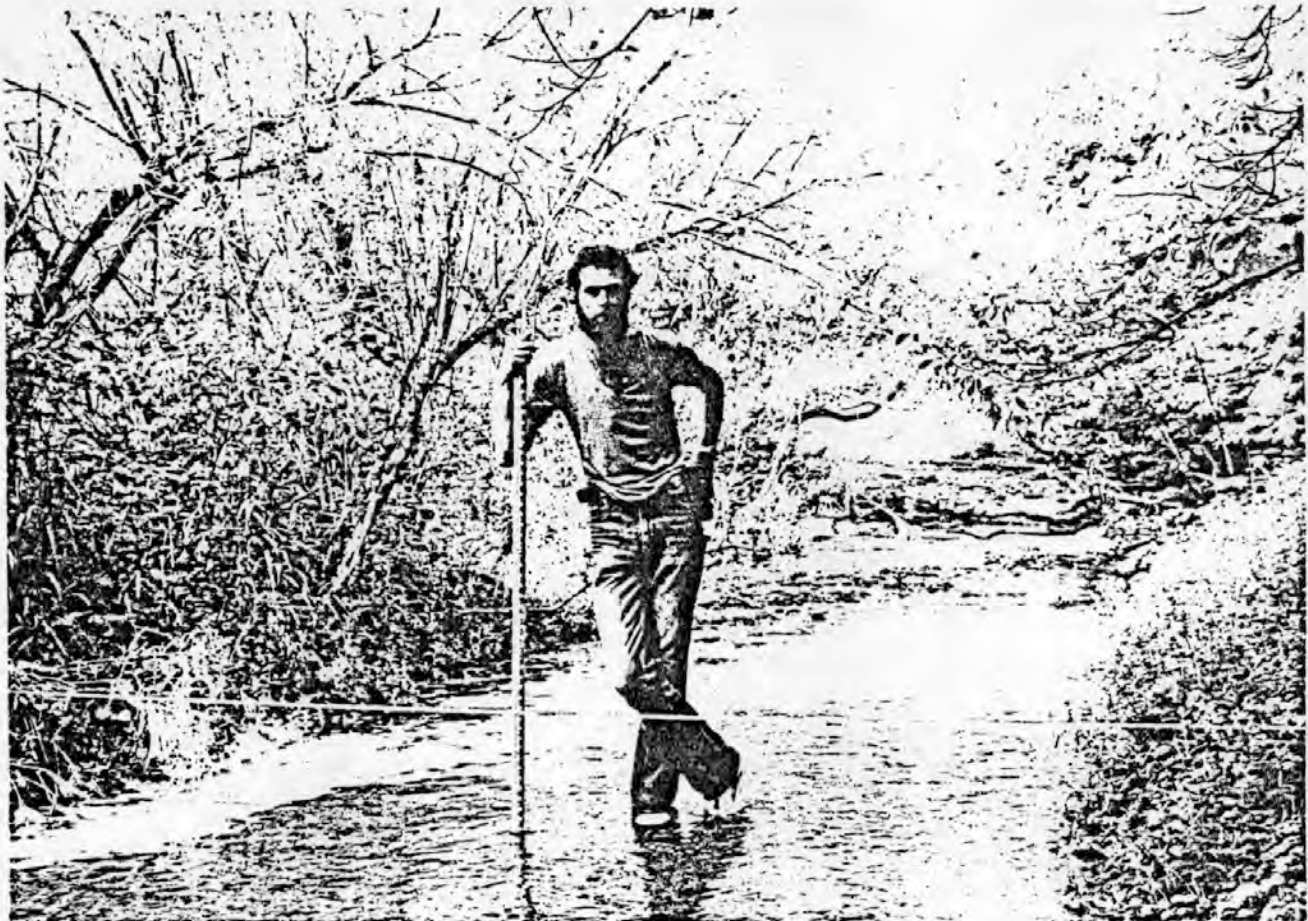
Plate 7. Monitor Station 7, upstream gage.
